# TOTO

# "EGO II" CROSS HANDLE COMBINATION SHOWER SET TX446SEC

# **SPECIFICATIONS**

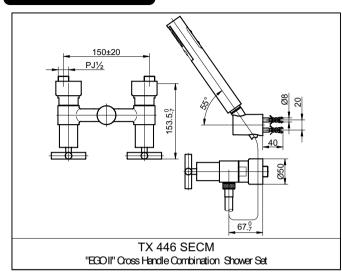
MOUNT CONNECTORS PARALLEL WITH
THE WALL
Hot
Water
Supply

150
Leg
